**Project Nr. F 040101**

***Determination and assessment  
of the continuous glowing combustion behaviour  
of building products in the SBI test method***

**Final report, October 2004**

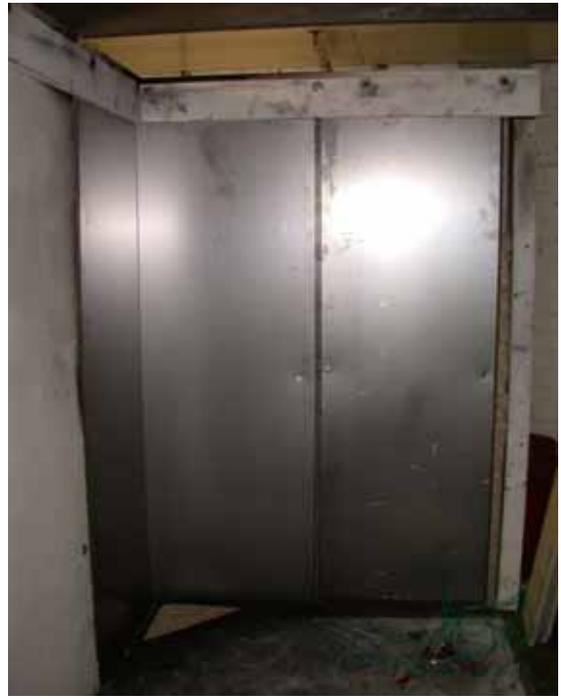
Steel sheet covering (screwed)

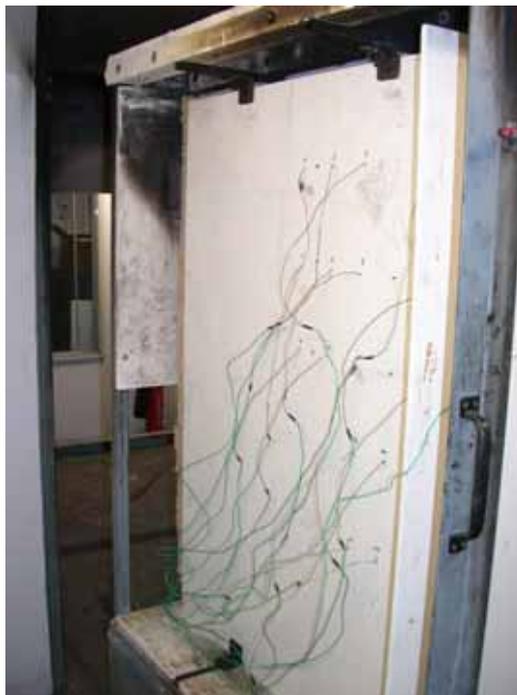
Thermocouples and substrate board

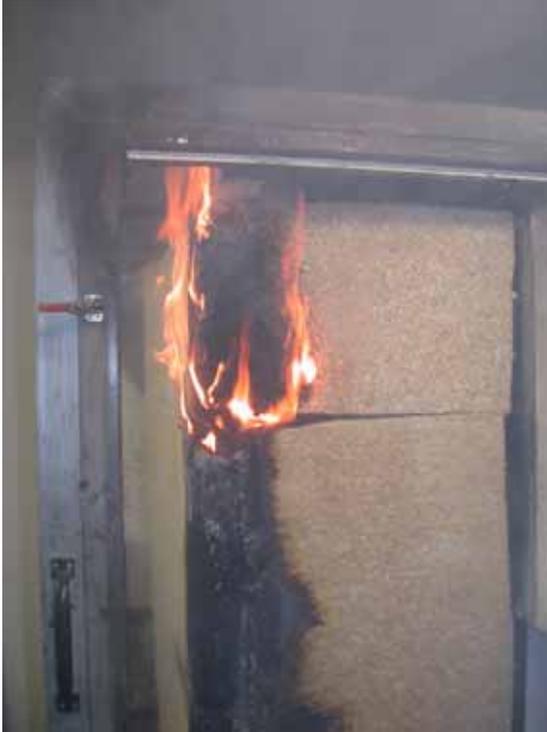
Self-ignition after test while removing sample from SBI

In this test the most significant continuous glowing combustion behaviour of all tests conducted was observed. At the beginning of the test, temperature increases were detected at all measuring points resulting from the flame impingement. After switching off the burner (after 21 minutes) temperatures decreased. Since the heat transfer within the test material is mainly by conduction the height of a temperature peak and the time to reach the peak depend on the distance of a thermocouple from the heat source (i. e. the burner flame or the glowing combustion zone, respectively). That means that high maximum temperatures and short periods to reach the maximum temperature are associated with small distances from the heat source and vice versa (e. g. the highest temperatures at the beginning of this test were recorded by the measuring points MS-14 and MS-16 that were both located the nearest to the burner flame). However, after about 120 minutes some thermocouples detected an increase in temperature again. This was caused by the heat release of a continuous glowing combustion fire within the hemp panel. The spread of the combustion zone (especially its upward moving in the specimen corner) can be seen clearly when considering the sharp temperature rises (up to about 350 °C) recorded by measuring points MS-16, MS-14, MS-12, MS-8 and MS-4 (marked by a red circle, cp. Annex A.1.1). The photographs in Annex A.1.1 show the parts of the hemp sample that were affected by the continuous glowing combustion fire. Even self-ignition of the sample occurred when it was removed from the SBI because of the high thermal potential still present within the material and the sudden increase in oxygen supply.

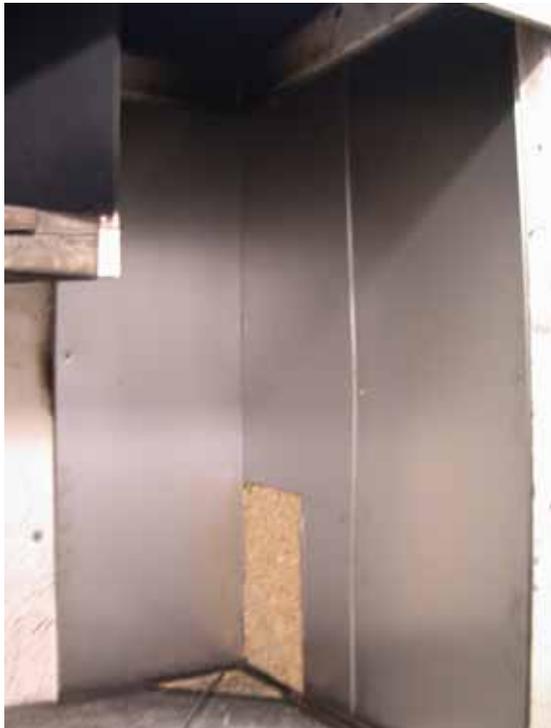
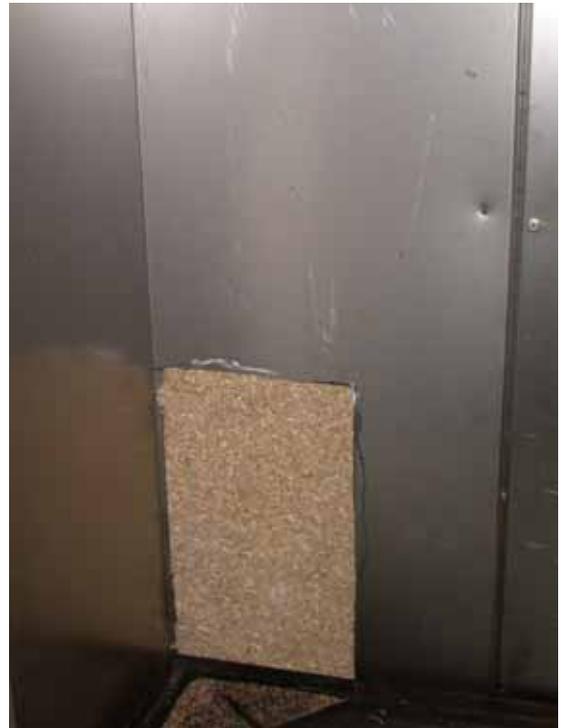
Test setup, steel sheet with opening

Opening  $50 \times 30 \text{ cm}^2$  at the long wing

In the second test with hemp an opening (50 cm × 30 cm) was provided in the steel sheet covering enabling a direct contact between the burner flame and the material surface. Both, continuous glowing combustion and flaming combustion occurred. The uncovered surface of the hemp sample ignited during the flame impingement and the flaming fire proceeded behind the steel sheet. After switching off the burner, flaming combustion continued especially affecting the corner of the specimen. Continuous glowing combustion occurred in areas of the sample adjacent to the flaming zone, partially followed by flaming ignition after some time. As can be seen in Annex A.1.2, high temperatures (> 700 °C) were measured resulting from the flaming combustion. Due to the high energy release and sample mass loss comparatively large amounts of smoke particles, CO and CO<sub>2</sub> were released. Since the occurrence of both, flaming and continuous glowing combustion, prevents a well-defined assessment of the continuous glowing combustion behaviour an opening in the steel sheet covering was not provided anymore in the following tests.

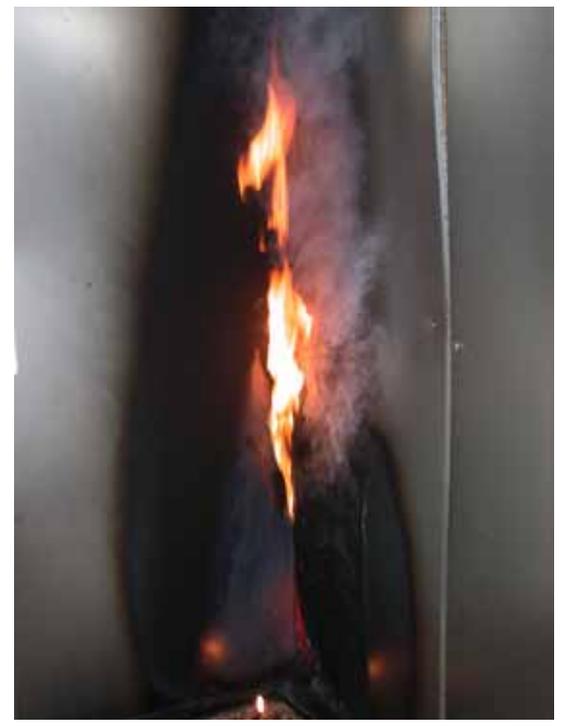
Ignition of pyrolysis gases at the opening  
(burner switched off)

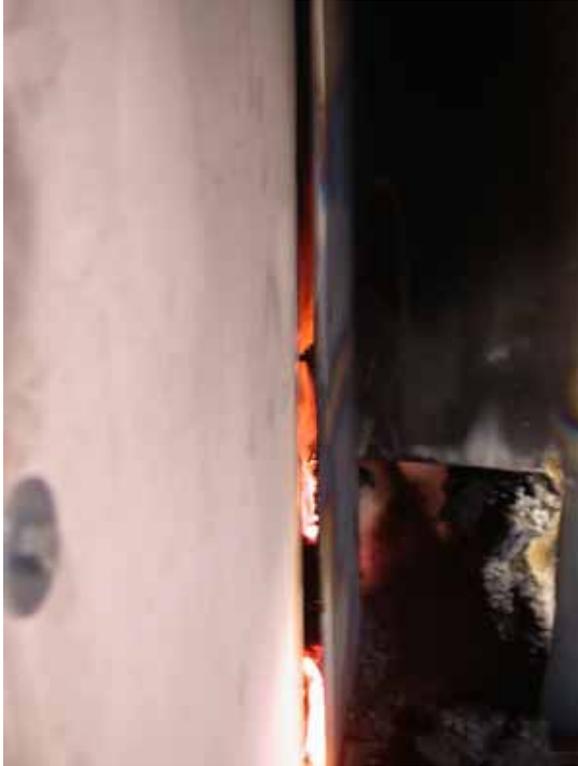
Flames behind steel sheet

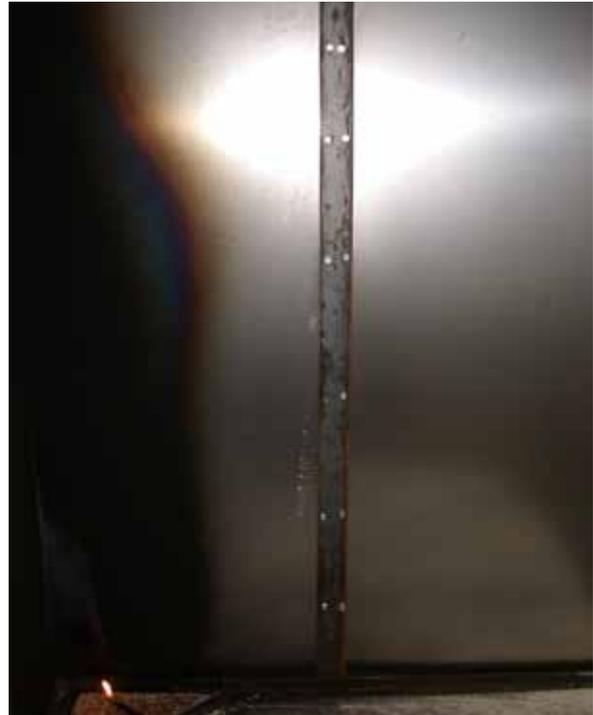
Flat bar in front of the joint between the two pieces of steel sheet (long wing)

As warping of the steel sheets was observed in the previous tests an L-profile and a flat bar were additionally mounted on the covering in this test (cp. test setup shown in Annex A.4). Thus, the problem of warping could be reduced. This slightly modified test setup was also employed in the following tests.
