Assessment of the Fire Behaviour of Insulated Steel Deck Flat Roofs

This factsheet describes the test method and details the outcome of its application to flat roof assemblies with different insulation materials.

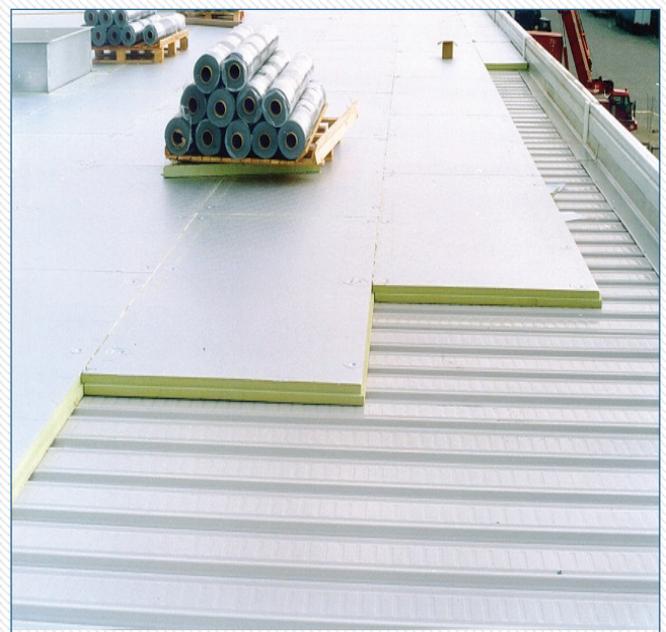
Figure 1: Example of a roof construction containing a steel deck support, PIR insulation and a roof covering

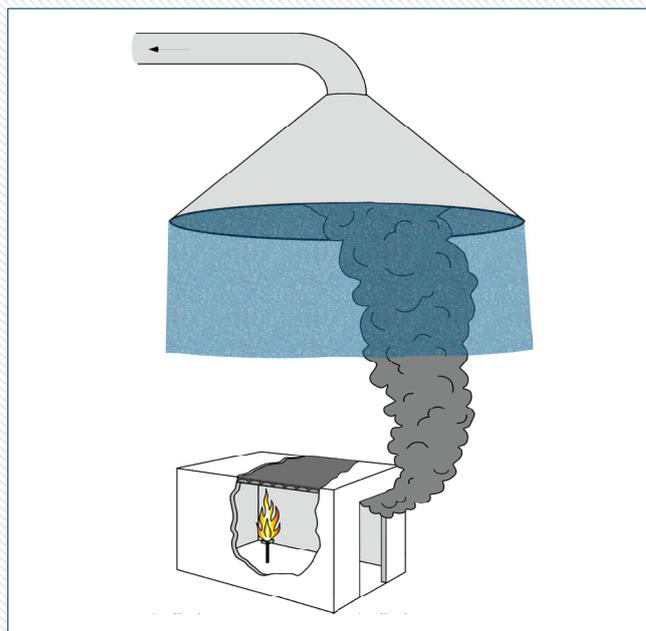
Figure 2: Schematic drawing of the test set-up under a large calorimeter hood

The geometry of the test apparatus is the same as for the ISO 9705 room corner test. The floors and walls are made of lightweight concrete, while the roof is constructed and tested simulating the end use application (**Figure 2**).

The tests are performed under a 6 metre diameter calorimeter hood (**Figure 2**). This is used to measure the heat release rate (HRR). Thermocouples, placed between the insulation and the waterproofing membrane, are used to monitor temperature development and insulating performance. Thermographic images are recorded from above the roof with an Infra-red (IR) camera. These can provide a good visual representation of heat emission from the roof, and can measure the temperature of the upper roof surface. The temperature measured by the IR

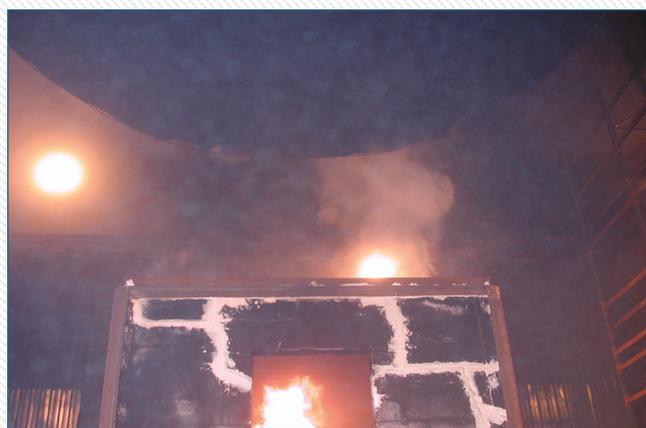
Figure 3: Substantial smoke release through the roof

The most critical part of the roof assembly is the edge detail. It is very important to ensure that combustible gases and smoke can not escape through the roof assembly or its edges, so called 'venting' (**Figure 3**). Tests carried out during the development of this test method showed that when 'venting' occurs the heat release measurement is unreliably low and flashover is inhibited. The test is thus no longer representative of reality and repeatability is lost. The edge detail is constructed as below (**Figure 4**).

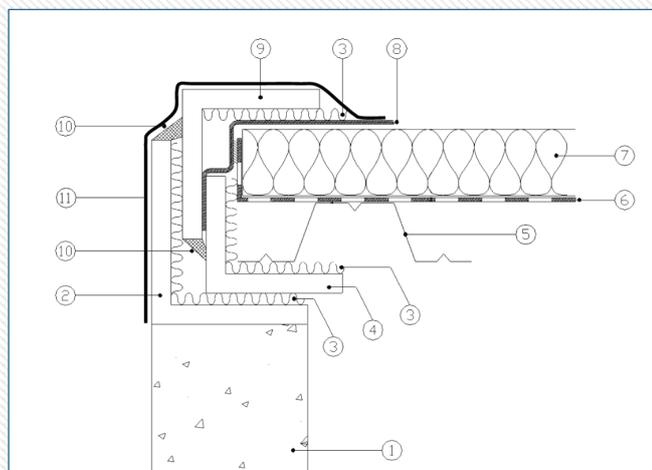
1. non-combustible lightweight concrete wall
2. frame permanently attached to the room
3. ceramic wool
4. bottom frame
5. steel deck
6. vapour control layer
7. thermal insulation
8. waterproofing membrane
9. top frame
10. welds, at two points on each side
11. bituminous waterproofing membrane strip to seal the deck

Figure 4: Schematic of the edge detail

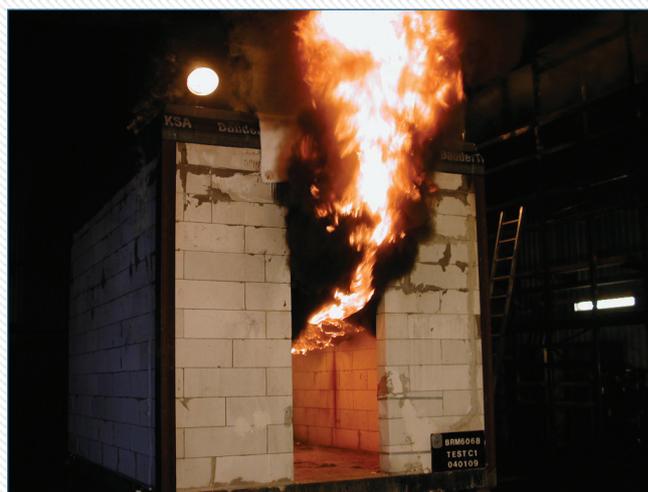
Figure 5: Illustration of flashover during the test

- When flashover occurs during the test or during the observation period after the burner is stopped (**Figure 5**).

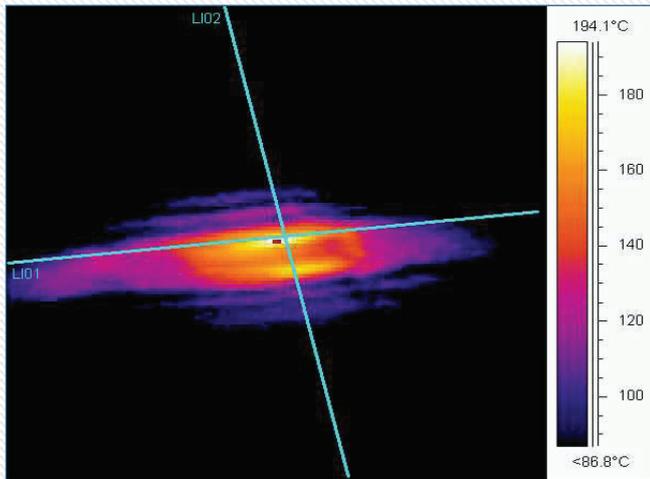
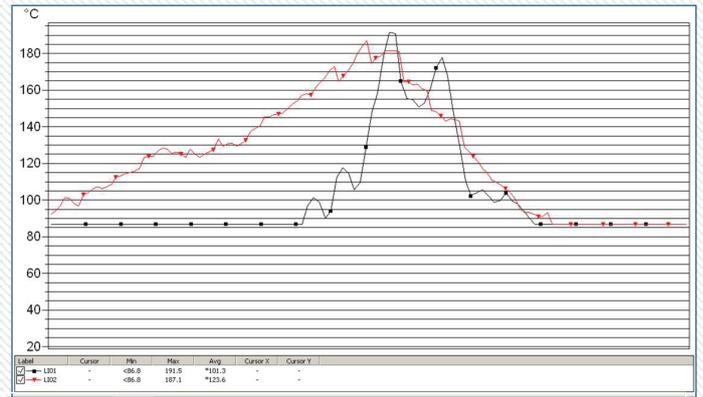
Flat Roof Insulated with EPS
Elapsed time = 22:00 minutes

Figure 6: Thermographic images recorded from above the upper surface of the roof assembly and graphs of the surface temperature profiles along the latitudinal and longitudinal lines L01 and L02

EPS caused flashover. At flashover, the fire continued until all the material was burned. It did not self-extinguish. A back-flash occurred, on several occasions, after manual extinction. The integrity of the roof was completely destroyed.

Figure 6 shows thermographic images taken towards the end of the tests. The graphs show upper surface temperature profiles on the lines plotted on the thermographic images. For both rock mineral fibre and PIR, the upper surface temperature of the roof was still low at the end of the test, while for EPS the roof temperature at 22 minutes reached 200 °C at which point thermographic imaging was interrupted.

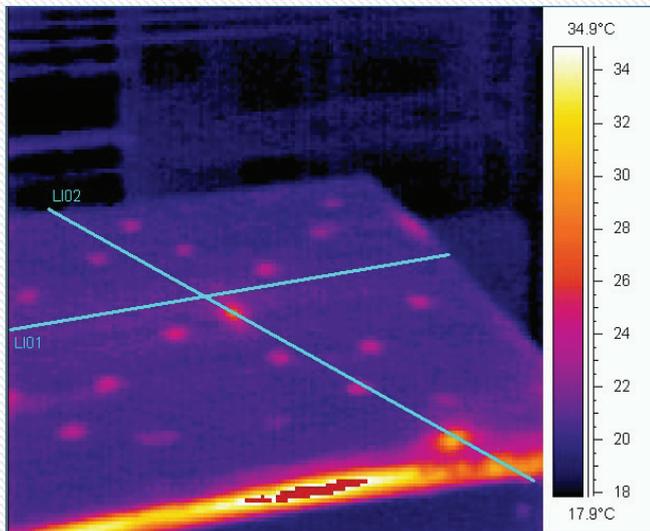
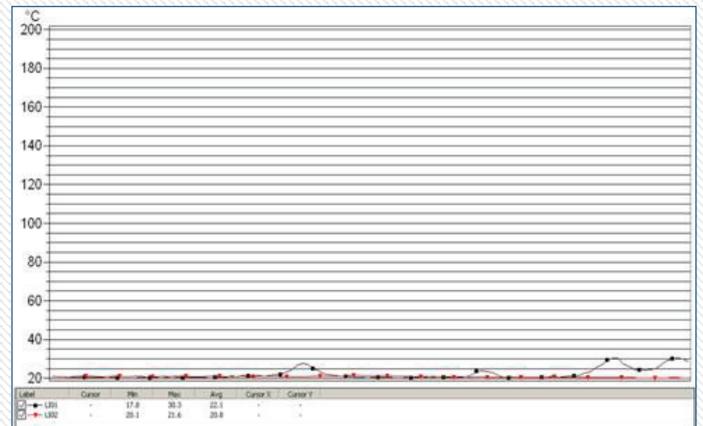
Flat Roof Insulated with Rock Mineral Fibre
Elapsed time = 30:00 minutes

The rock mineral fibre insulation was visibly heat damaged to about 30% of its thickness.

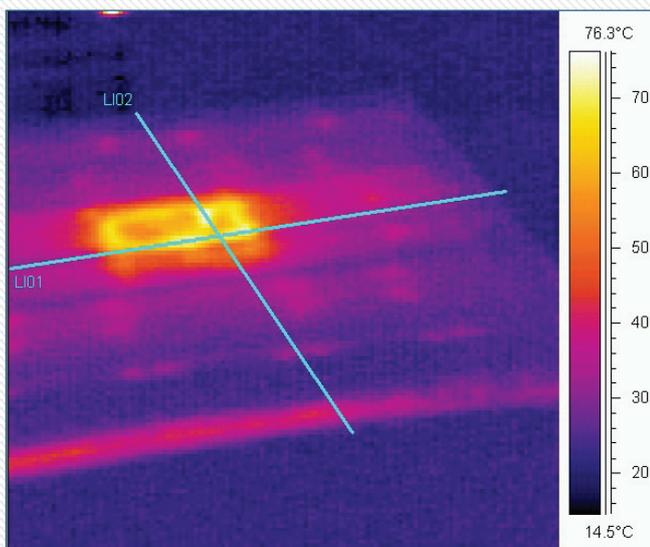
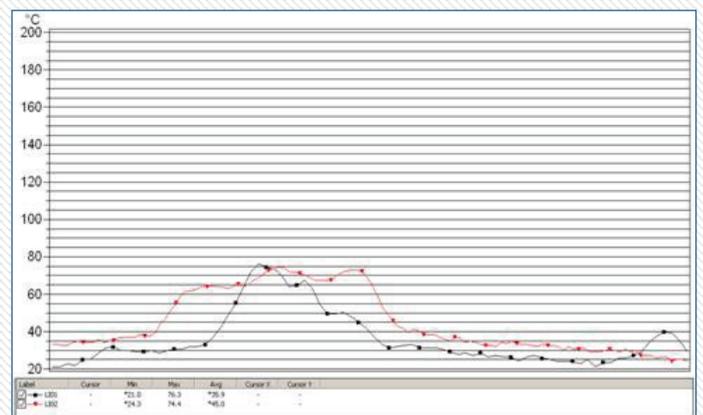
Flat Roof Insulated with PIR
Elapsed time = 29:30 minutes

For the roof insulated with PIR, the insulation was charred over the whole surface, above the burner to about 75% of the thickness, but with the degree of char decreasing with increasing distance from the burner. The flames self-extinguished soon after the burner had stopped.

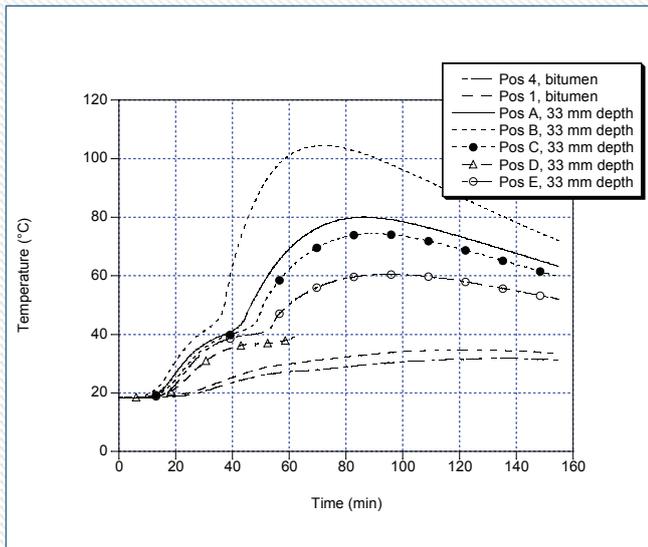
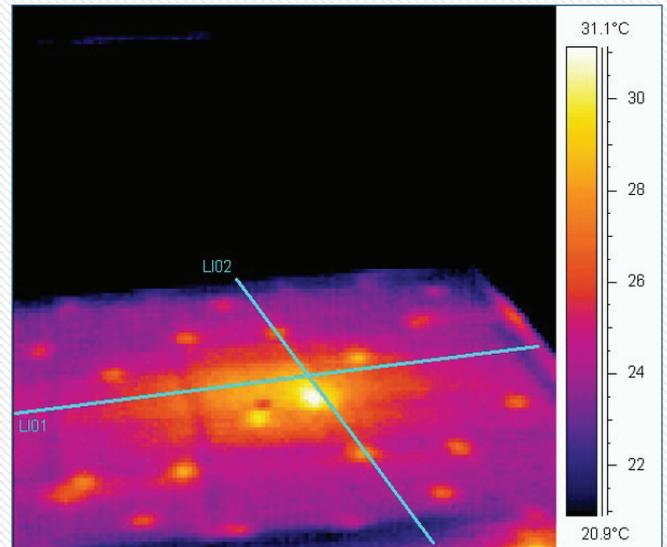
Figure 7: Temperatures within the insulation (0-160 minutes) in roof assembly insulated with rock mineral fibre. Thermocouples in positions 1 and 4 are at the interface between the insulation and the waterproofing membrane. Those at positions A to E are buried 33 mm below the top surface of the insulation material. Thermographic image recorded from above the upper surface of the roof assembly insulated with rock mineral fibre after 1 hour and 40 minutes

Figure 7 shows a temperature increase in the rock mineral fibre insulation after the burner had been shut off. This is interpreted as some onset of punking after

the burner was extinguished. The cellular plastic insulation materials tested did not exhibit punking.
